PRIMARY RECORD

* Resource Name or #: 6232 Anthony Avenue

c. Address 6232 Anthony Ave City Garden Grove Zip 92845

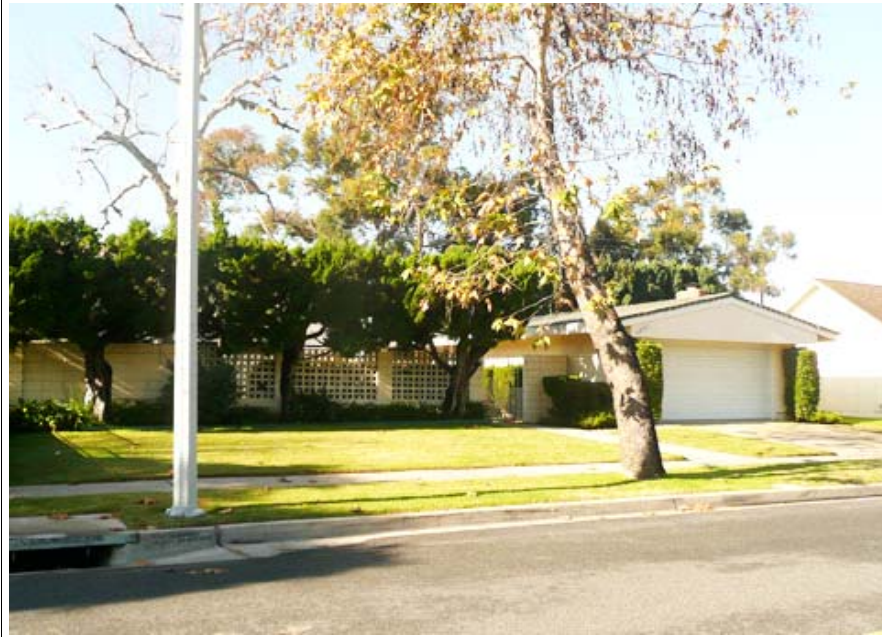
Facing southwest; 2/10/2010; Photo No.
P1030815.jpg

* P3a. Description: (Describe resource and its major elements. Include design, materials, condition, alterations, size, setting, and boundaries.)
The one-story Ranch style building is 'L'-shaped in plan. The cross gabled roof is clad in composition shingles. A brick chimney is located on the northern elevation. The exterior walls are clad in vertical wood siding. An attached two-car garage projects from the northern end of the primary (eastern) façade. A concrete block and screening block encloses the front courtyard. Aluminum fixed-pane and casement windows open onto the courtyard. Other details were not discernable from the public right of way. The building does not meet the NRHP and CRHR eligibility criteria for the reasons identified on the district record prepared for this subdivision; therefore the building does not contribute to a historic district and is not individually eligible for listing in the NRHP and the CRHR.

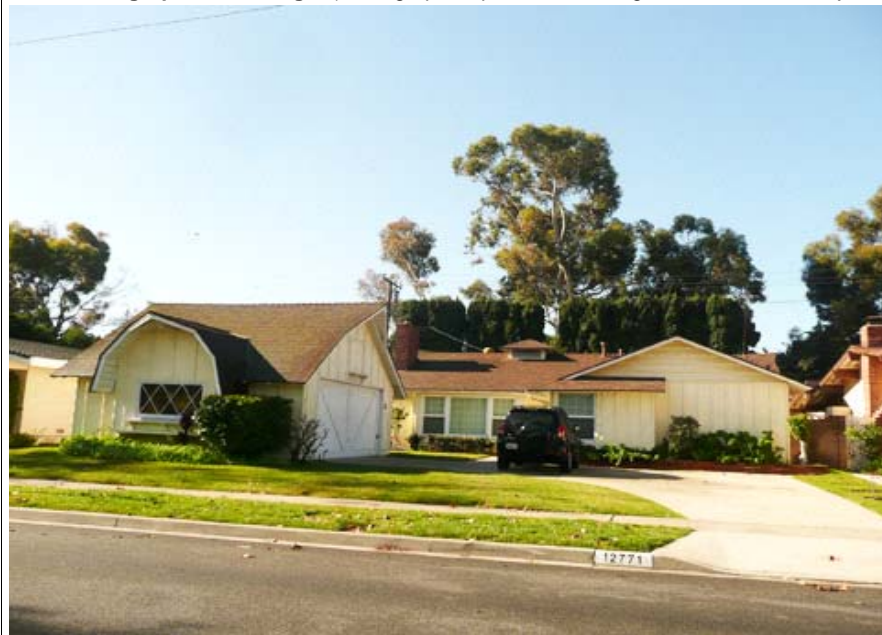
Facing southwest; 2/10/2010; Photo No.

* P3a. Description: (Describe resource and its major elements. Include design, materials, condition, alterations, size, setting, and boundaries.)
The one-story Ranch style building is 'L'-shaped in plan. The cross gabled roof, with flared and boxed eaves, is clad in composition shingles. A cupola is centrally located on the roof crest. The gables are further accented with wavy-edge horizontal wood siding. A brick chimney is located on the southern elevation. The exterior walls are clad in vertical decorative board and batten siding and smooth textured stucco. The windows have been replaced with vinyl sash units; however, the diamond-paned pebble glass window on the eastern façade of the detached garage appears to be original. The primary entrance is at grade. A detached two-car garage, with wood pivot door, is located in the front of the parcel. The detached garage is of a similar style as the main building. The easterly gable of the detached garage is accented with a gambrel roof. The building does not meet the NRHP and CRHR eligibility criteria for the reasons identified on the district record prepared for this subdivision; therefore the building does not contribute to a historic district and is not individually eligible for listing in the NRHP and the CRHR.
